Charles Selwitz

**Epoxy Resins  
in Stone Conservation**

p. cm. — (Research in conservation : 7)

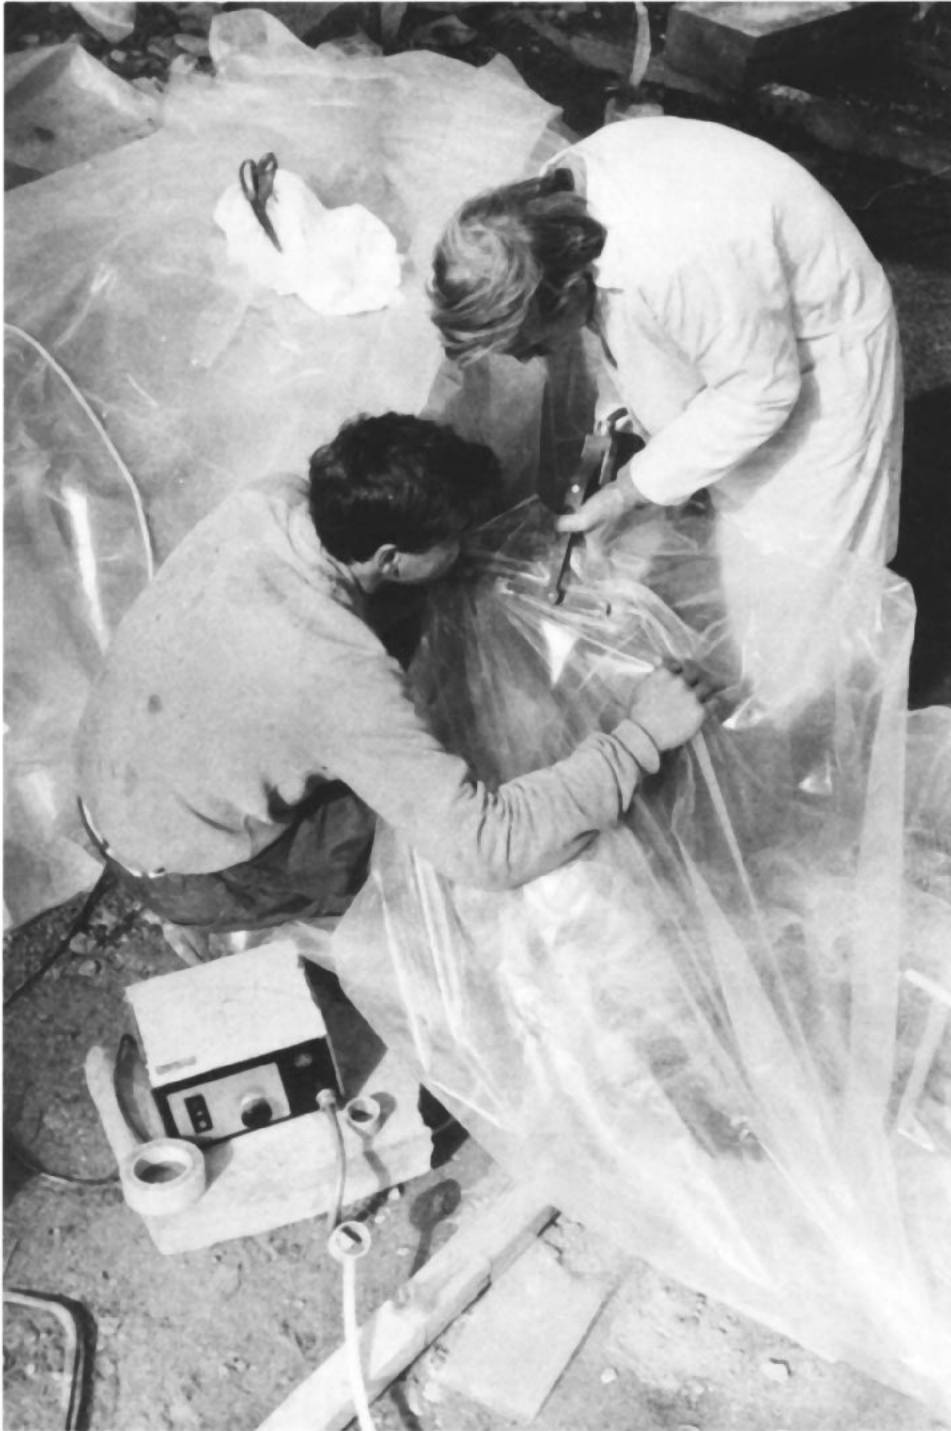
*Professor Petr Kotlik (right) and his assistant are heat-sealing polyethylene film to create a containment chamber around a limestone statue as part of a routine program for treating statuary with epoxy resins in solutions.*

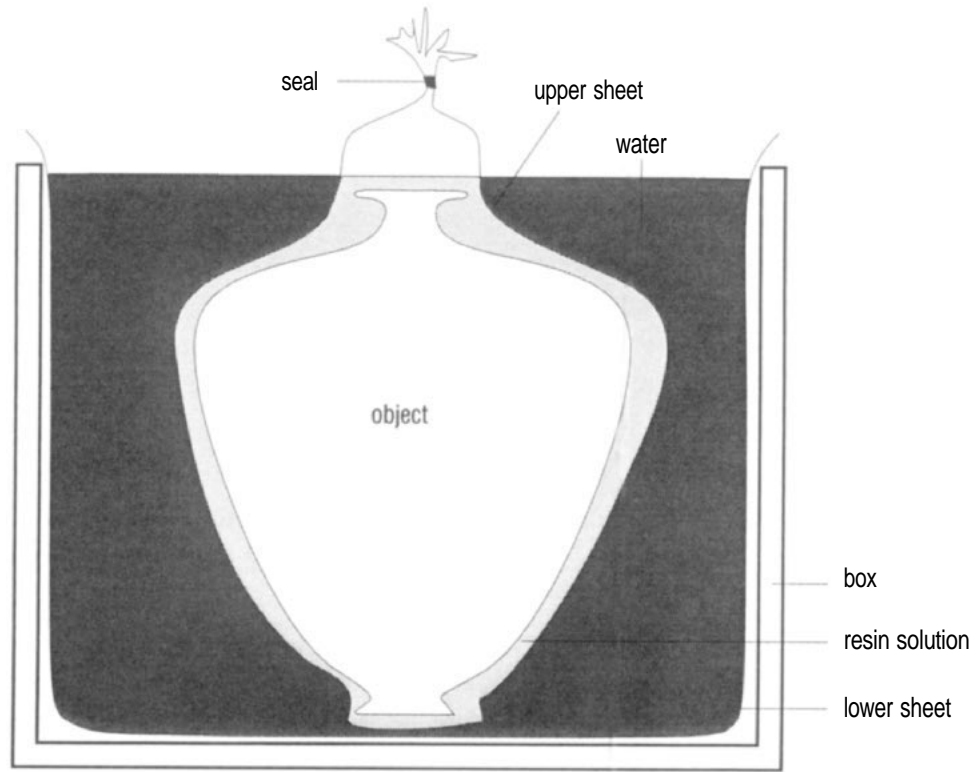
Figure 2. Scheme for consolidating stone with epoxy resins using the containment method.

For the treatment of smaller, more valuable stone artifacts the European approach is likely to be more suitable. Cycloaliphatic epoxy resins such as Shell's Eponex or STAC's EP 2101, in particular, should be evaluated as consolidants. In the treatment of the plinth of the statue on the left side of the lateral portal in the Santa Maria Maggiore Church in Trent, Italy the stone was placed in a solution of 24% EP 2101 and 5% aliphatic polyamine hardener in an isopropanol and toluene blend in a waterproof plastic film container. This was immersed in water, which produced useful hydrostatic pressure. When the solution turned to gel, the plinth was removed and the gel was brushed away to leave well-consolidated stone. In other situations, the necessity for further cleaning would depend on the type of stone and the nature and quality of the ingredients in the consolidating solution. This procedure, developed by Lazzarini, is a generally useful method for the stabilization of objects that are not too large in size. Figure 2 illustrates how this can be done. A wood box, built to contain the object, is draped with two sheets of 3 mil polyethylene film. The artifact is placed on the upper sheet. Resin solution is poured into this containment and the upper sheet is pulled up and gathered. The space between the outer and lower sheets of polyethylene is then filled with water to a level above the object. After the amount of resin solution is adjusted so that a minimum volume covers the object, the containment formed by the upper sheet is sealed at the gathering point. In time, gel formation occurs and the object can be removed and cleaned.

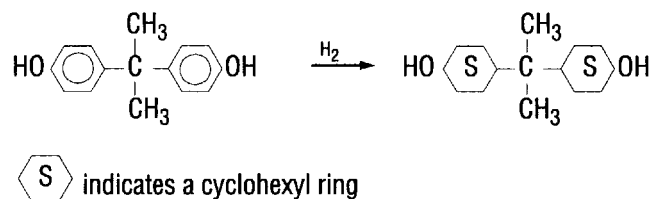
Equation 5.

Promising resins for stone consolidation are produced commercially from bisphenol A by hydrogenation to 2,2-di(4-hydroxycyclohexyl) propane and reaction of this compound with epichlorohydrin (Equations 5-6).

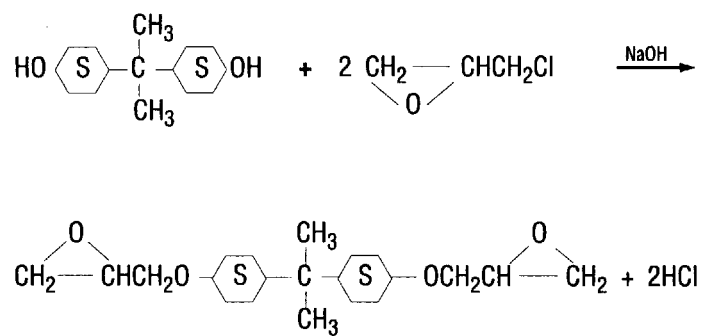
Equation 6.

The resulting cycloaliphatic molecule is bulkier and less linear than bisphenol A glycidyl ethers. This and the conversion of rigid benzenoid structures to molecularly flexible cyclohexyl rings provides products such as Shell's Eponex resins with sharply lower viscosities (Table 6) and better light stability than their aromatic counterparts. The use of diglycidyl ethers of relatively small aliphatic glycols, such as 1,4-butanediol, to produce epoxies that have low solution viscosities, has not worked well. Kotlik (1990) found that a resin based on butanediol diglycidyl ether, even after curing, showed a strong tendency to absorb water in a manner typical of polyols like glycerin. A sample of sandstone impregnated with this resin was destroyed by immersion in water due to the swelling of the consolidant. The interaction of water with relatively nonhydrophobic resins can cause absorption and plasticization, lowering of glass transition temperature, and disruption of bonding in the interfacial region between stone and polymer. Epoxy resins with relatively high ratios of oxygen to carbon-hydrogen structure can absorb considerable amounts of water. Additional factors affecting the amount and rate of absorption are hardener composition, temperature, and humidity (Shaw 1988).

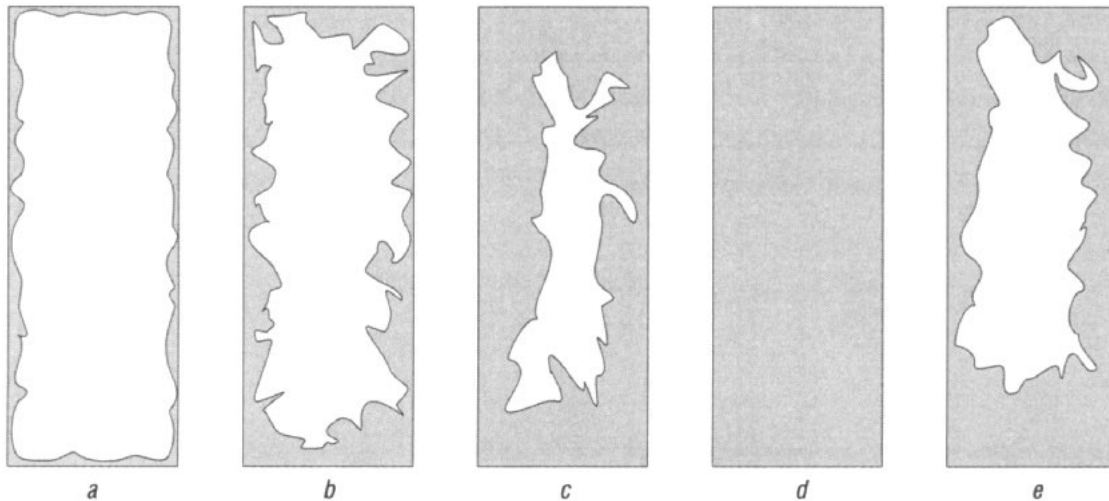
Figure 3. Cross sections of sandstone samples after impregnation by immersion in epoxy resin solution, MW= 460, hardener DETA. Concentration of solution: (a) 5-6%, (b) 10%, (c) 30%, (d) 50%, and (e) 75%. All concentrations are by weight. Impregnated area is indicated by dots (Kotlik 1983).

In this study, sandstone blocks were immersed in solutions of bisphenol A diglycidyl ether (MW = 460) and diethylenetriamine in a methanol-toluene co-solvent for three hours, and then were wrapped in aluminum and polyethylene sheets for two weeks. These steps

eliminated reverse migration. In the immersion phase, the lower molecular weight, more mobile solvent molecules penetrate the pore structure more easily than the resin. However, as the resin concentration increases, the concentration differential increases and forces the resin to flow more deeply into the stone.

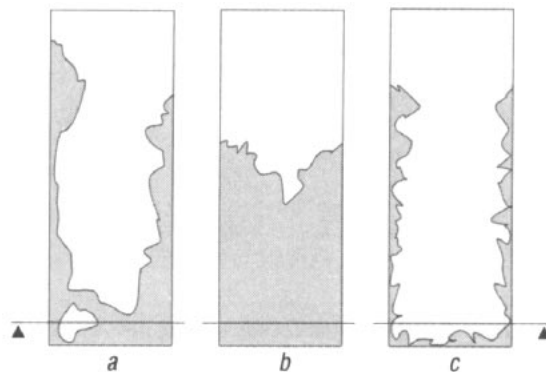
Figure 4. Cross sections of sandstone samples after impregnation by capillary rise with bisphenol diglycidyl ether resin solution: (a) epoxide MW= 460, concentration 10%; (b) epoxide MW= 460, concentration 30%; (c) epoxide MW= 1710, concentration 10%; hardener DETA. All concentrations are by weight (Kotlik 1983).

Kotlik found that using higher resin concentrations to provide deeper penetration provided a better quality of consolidation. Table 4 shows these benefits as the concentration of resin is increased from 2.9 to 30%. The samples were immersed at reduced pressure for three hours. At a 2.5% polymer loading, obtained by using a 30% solution, the sandstone showed

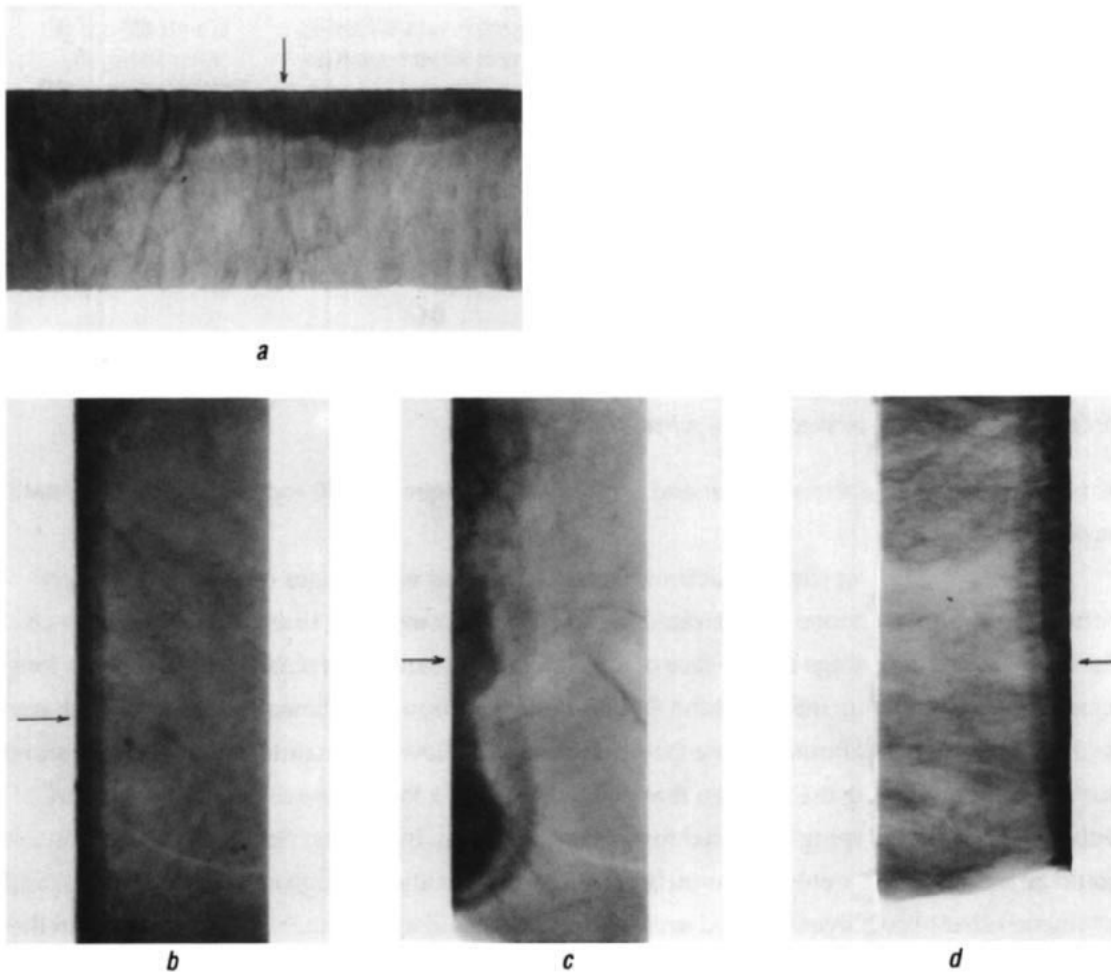
Figure 5. Penetration of epoxy resin into sandstone slabs. (a) Brushing on horizontal surface. (b) Brushing on vertical surface. (c) Contact flow for 5.5 hours. (d) Contact flow for 10 hours (Kotlik 1990).

The improved penetration that is obtained with longer durations of contact between solution and stone is illustrated in experiments comparing brushing and flow procedures. Repeated brushings on one face of a 5 x 15 x 30 cm sandstone slab were done for as long as solution was taken up into the stone. In the continuous flow experiments a cellulose wick was soaked in solution and bound to one face of the slab. The flow was maintained against the stone surface by recirculating the solution that was collected in a lower vessel and returned to an upper vessel. No wrapping was used for solvent retention. In the first flow experiment, contact could be maintained for only 5.5 hours because the combination of high resin concentration and a toluene-ethanol co-solvent caused accelerated curing and a rapid increase in viscosity. In the second flow experiment, the toluene was replaced with acetone. This slowed polymerization and permitted the application of resin to be continued for 10 hours. The slabs were cut open and the depth of penetration was determined by neutron radiography. The results are shown in Figure 5. The first two illustrations show the patterns of impregnation obtained by brushing. Figure 5a shows the result of brushing the top of a horizontal surface, while 5b demonstrates the penetration obtained on a vertical slab. Brushing a vertical surface results in a relatively even penetration of about 5 mm with most of the resin accumulating in a dense region close to the surface. The flow treatments gave penetrations of 1 to 3 cm without a dark, concentrated layer near the surface. The 10-hour period of treatment appears to have provided the deepest, most uniform distribution of epoxy resin (Fig. 5d).

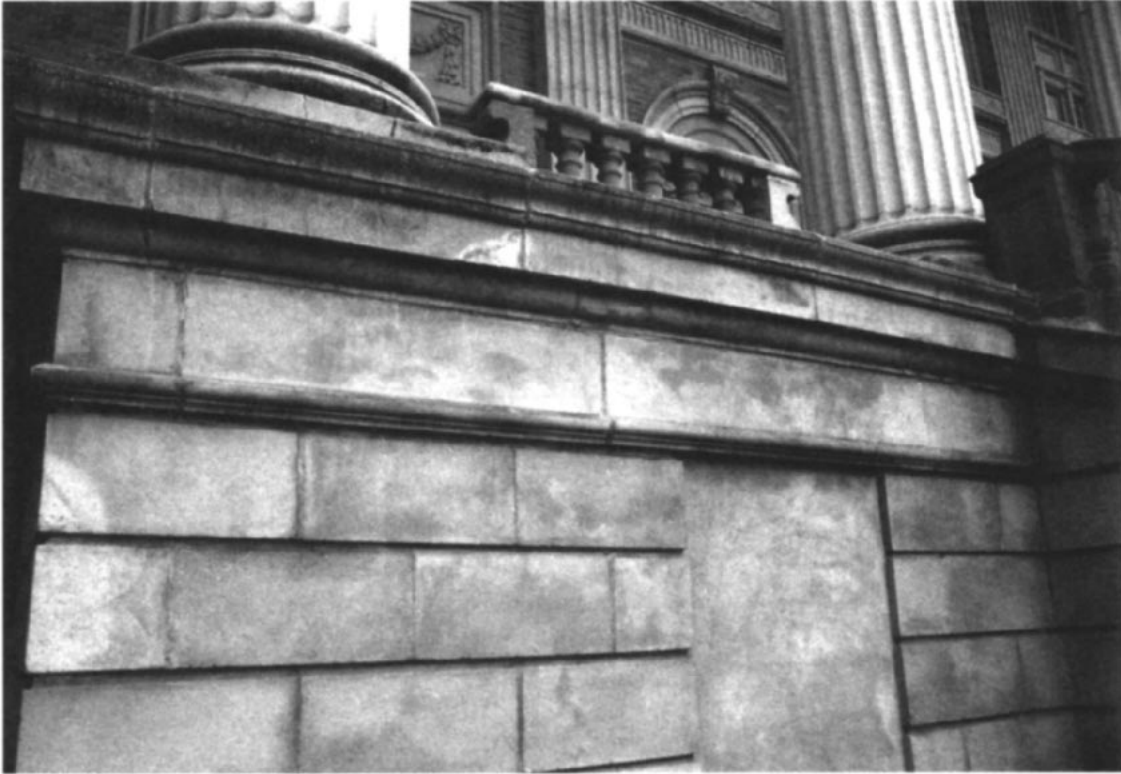
*Figure 6. Exterior of Crescent Hill Baptist Church, Louisville, Kentucky, treated with epoxy resin in 1983. Figure shows the tones of the treated surface in 1989.*

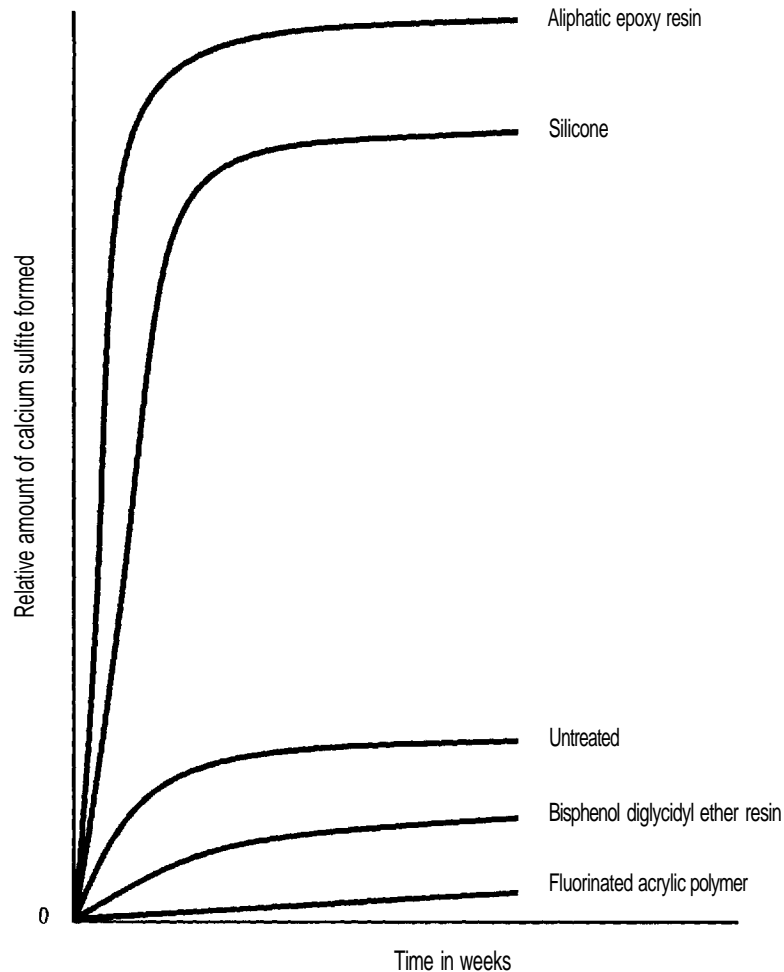
Figure 7. Relative protection of marble against attack by sulfur dioxide and water by different consolidants.

Gauri and Madiraju (1978) compared the ability of several resins (an aromatic epoxy resin based on bisphenol A diglycidyl ether, an aliphatic epoxy resin of undisclosed structure, silicone resins, and a fluorinated acrylic polymer) to protect marble against attack by sulfur dioxide. In one phase of their study, impregnated marble slabs were placed in reaction chambers and subjected to an air flow, containing from 6 to 11 ppm of sulfur dioxide, at 100% relative humidity. The rate of reaction was determined by periodic measurement of calcium sulfite buildup using X-ray diffraction analysis. The results are shown schematically in Figure 7. Gauri found that an aliphatic epoxy resin and several different silicones actually increased the rate of attack over untreated marble. Presumably, these materials were acting as sponges to hold aqueous sulfurous acid against the marble surface. An epoxy resin based on bisphenol A diglycidyl

ether provided substantial protection, while fluorinated acrylic resin appeared to suppress corrosion completely. Based on these findings, Gauri advocated a treatment where stone is first impregnated deeply with an epoxy formulation based on bisphenol A diglycidyl ether, and then the surface is treated with an appropriate fluoropolymer.

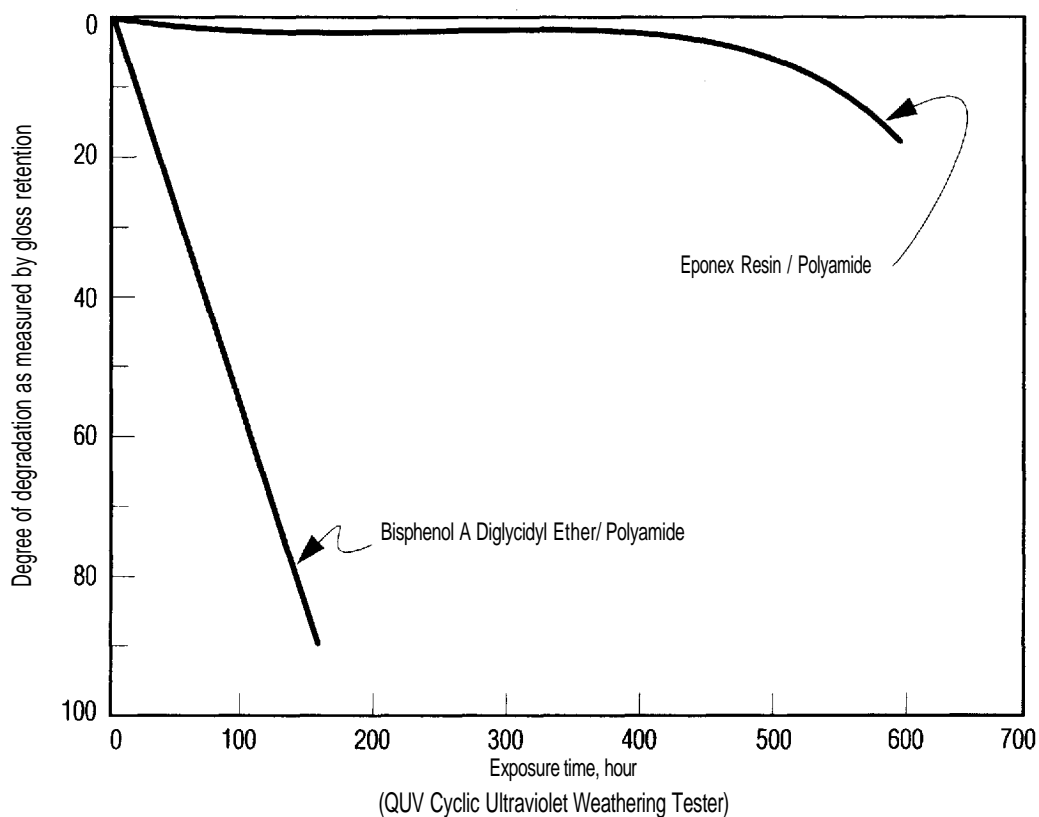
Figure 9. Comparison of the stability of cycloaliphatic and aromatic epoxy resins to ultraviolet radiation-induced autoxidation (courtesy of R. S. Bauer).

Eponex 1510 has a viscosity of only 2000 cP at 20 °C compared to 10,000 -16,000 cP for dimensionally similar, conventional bisphenol A epoxy resins. The improved light stability of this resin is demonstrated in Figures 9 and 10. The first figure describes results of exposing polymer films to a QUV cyclic ultraviolet tester, which accelerates oxidative degradation of the resin and leads to a faster decrease in surface gloss. The retention of this property by the Eponex resin shows the greater stability to ultraviolet radiation of coatings made from an aliphatic epoxy resin over those produced from bisphenol A. Figure 10 similarly compares the Eponex surface to two other polymers known to provide films of high stability to ultraviolet-induced autoxidation, i.e., an acrylic-urethane copolymer and a polyester-urethane copolymer. These copolymers began to exhibit deterioration after 1000 hours when placed in a Xenon arc Weather-Ometer, while the Eponex product required 2500 hours to show similar behavior.

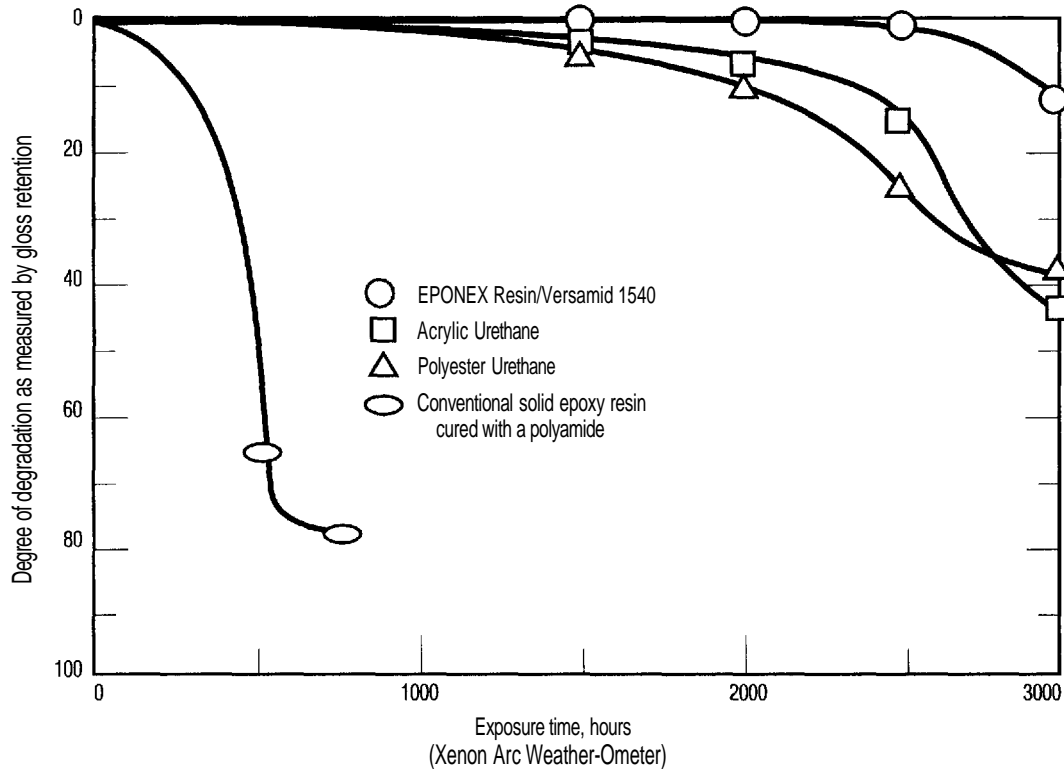
Figure 10. Comparison of the stability to ultraviolet radiation-induced autoxidation of cycloaliphatic epoxy resin to other resins of good stability (courtesy of R. S. Bauer).

These studies were done with polyamide-type curing agents, but even greater light stability and lower solution viscosities are obtained with the Jeffamine aminopoly-(oxypropylamine)s. Aliphatic resins are inferior to bisphenol diglycidyl ethers in two ways: Generally, they do not provide as great an improvement in mechanical strength as the aromatic types and they cure more slowly. However, the lower compressive and tensile strengths are still much higher than those provided by silanes or acrylic resins, but slow curing can be more of a problem. Eponex resins require about three times as long to harden than bisphenol derivatives and this must be taken into account when they are used. Since their introduction, weatherable epoxy resins based on hydrogenated bisphenol A have been successfully applied as clear coatings for wood, as a binder for decorative aggregate, and in many maintenance applications, but the literature does not mention their use for stone consolidation or other needs in art conservation.

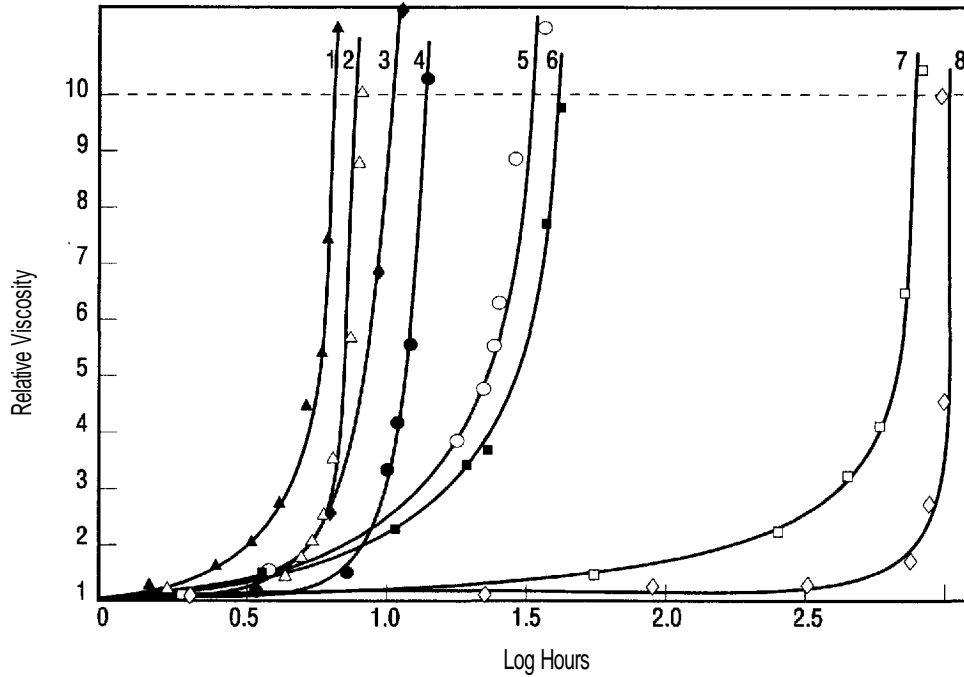
1. Xylene, Aminoamid D 500
2. Xylene, P1
3. Butyl acetate, Aminoamid D 500
4. Butyl acetate, P1
5. Cyclohexanone, Aminoamid D 500
6. Acetone, Aminoamid D 500
7. Acetone, P1
8. Cyclohexanone, P1

a. The resin consisted of 100 parts of bisphenol A diglycidyl ether, molecular weight = 450, with 40 parts of Aminoamid D 500 or 10 parts of P1, a mixture of technical grade aminopoly(ethyleneamine)s consisting primarily of diethylene-triamine. The treating solution was made up of 60 parts of resin and 40 parts of solvent.

A rundown of the effect of the seven solvents and three co-solvent blends on the time for a tenfold increase in viscosity, on whether precipitation occurs, and on the color of the cured resin is provided in Table 22 for experiments where the curing agent was the aminopoly(ethyleneamine) mixture. The table also provides information on the impact of resin concentration and variations in the alcohol-alkylaromatic co-solvent ratios. The authors agree with Domaslawski that alcohol-alkylaromatic hydrocarbon mixtures are the most suitable solvents for epoxy resins destined for stone applications, but favor ethanol over methanol as a blending agent with toluene because it is less volatile and less toxic, and it allows more control over whether the resin remains dissolved or precipitates. The absence of color was most noticeable in the co-solvent systems. Results were similar when the amine cross-linking agent was Aminoamid D 500 except that reaction was generally faster and there was more color than was obtained with the use of the aminopoly(ethyleneamine) (Table 23).

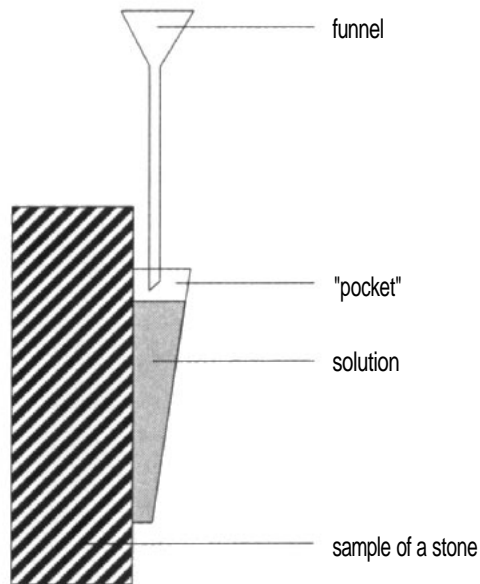
Figure 14. Saturation of stone by consolidant using the pocket method (Domaslawski 1969).

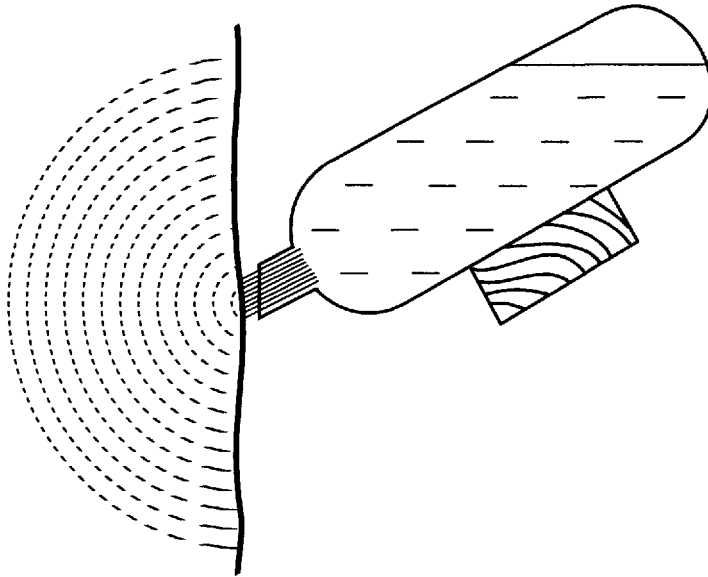
Figure 15. Small contact area with bottle impregnation.

Mirowski (1988) proposed a standing liquid procedure that impregnated stone through a large number of small contact areas as shown in Figure 15. The consolidant was supplied by a series of movable, 50-mm polyethylene vessels through a foamed polyurethane contact piece placed against bare rock which spread the consolidant through the stone as contiguous hemispheres. Vacuum release allows liquid to flow from the vessel only as long as there is uptake. Mirowski recommended the use of plastic film to deter the evaporation of solvents. This procedure would appear to be in conflict with Domaslowski's conclusion that the contact area should be as large as possible. Mirowski has suggested that the procedure could be modified by first covering the object with a cellulose poultice. However, it was found that while this enabled the surface to be impregnated much more rapidly and completely, the treatment was cumbersome and wasted consolidant.

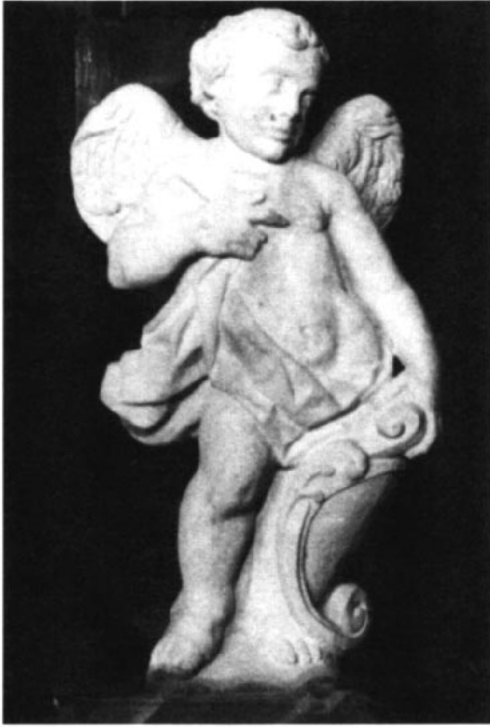
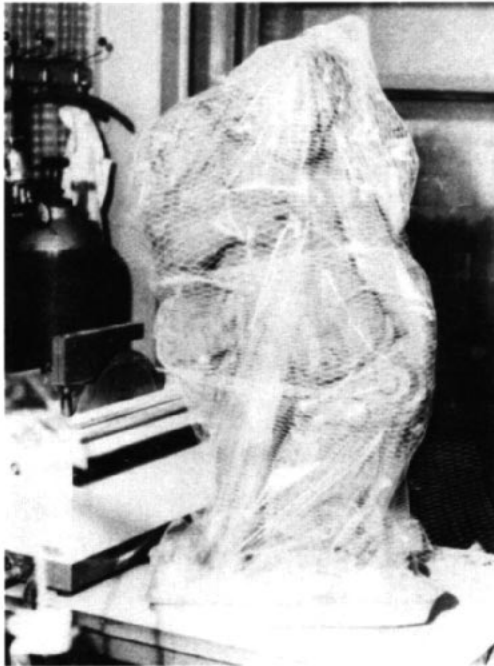
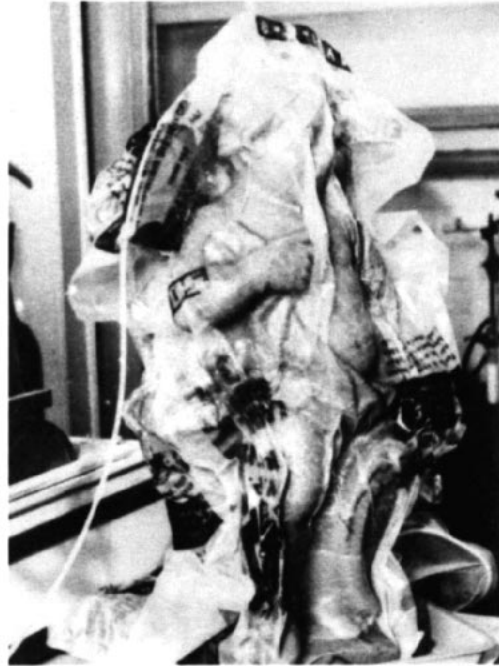
Figure 16. Reduced pressure impregnation of sandstone angel, (a) Angel before treatment, (b) Sculpture wrapped in netting, (c) Sculpture during impregnation (Kotlik 1990).

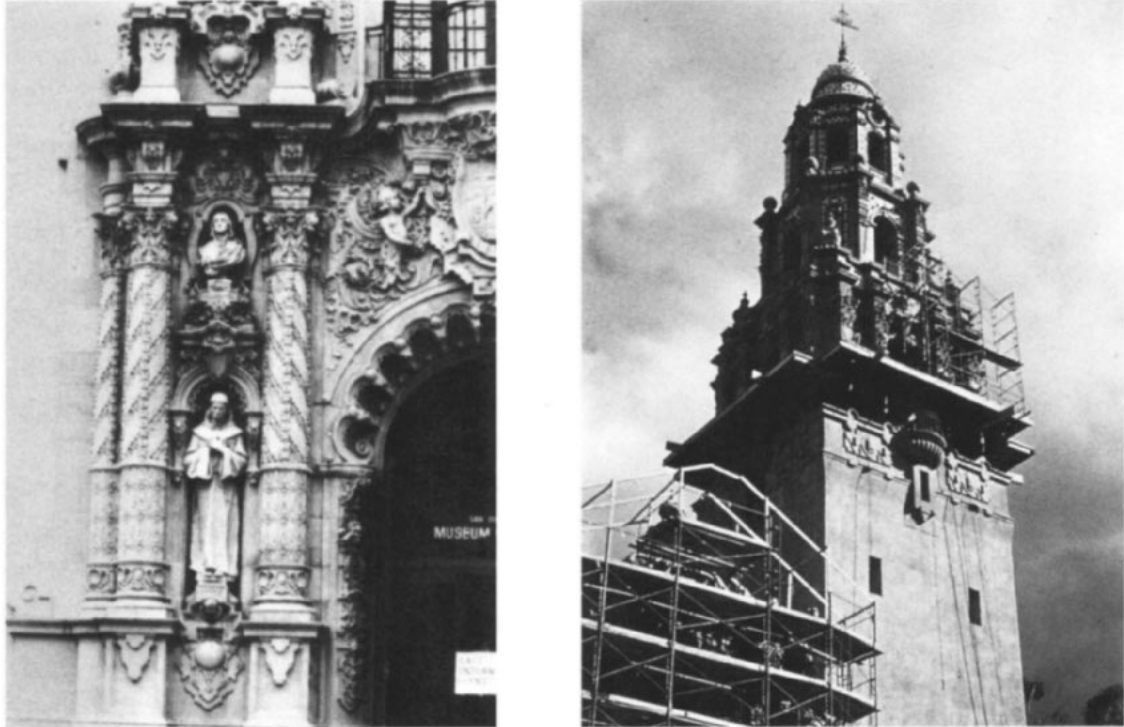
Figure 17, left. Spanish baroque reproductions on the California Building. 1969. (Courtesy of K. L. Gauri).  
Figure 18, right. Scaffolding on the tower. 1975. (Courtesy of K. L. Gauri)

The California Building consists of a central dome flanked by four vaults and a bell tower. The exterior is constructed of cast stone made from fine quartzose granules, coarse sand, and a lime cement. This composition gives it the weathering characteristics of a highly porous sandstone with a calcitic binder. There is extensive ornamentation and statuary of this same cast stone around the main entrance of the building and on the upper stories of the tower. It was in these areas and on the plain, stuccoed facade of the seven lower levels of the tower where chemical consolidation was ultimately carried out. In the mid-1960s, concern about cracks in the tower led to some interim repairs. But in the following decade accelerating deterioration

was seen in the disappearance of detail, in the wearing away of ornamentation, and in the seepage of water and salts into the interior, seriously reducing its mechanical strength. Parts of the ornamentation cracked, came loose, disintegrated, or fell away. In some areas, pieces of stone could be pulled off by hand. In 1975, it was recognized that \$630,000 necessary to strengthen and remortar 85,000 ft<sup>2</sup> of precast stone relief would be much less than the cost of replacing the complex (Maydeck 1975). Figures 18 and 19 show the scaffolding used to carry out the treatment and provide a sense of the magnitude of the intervention.

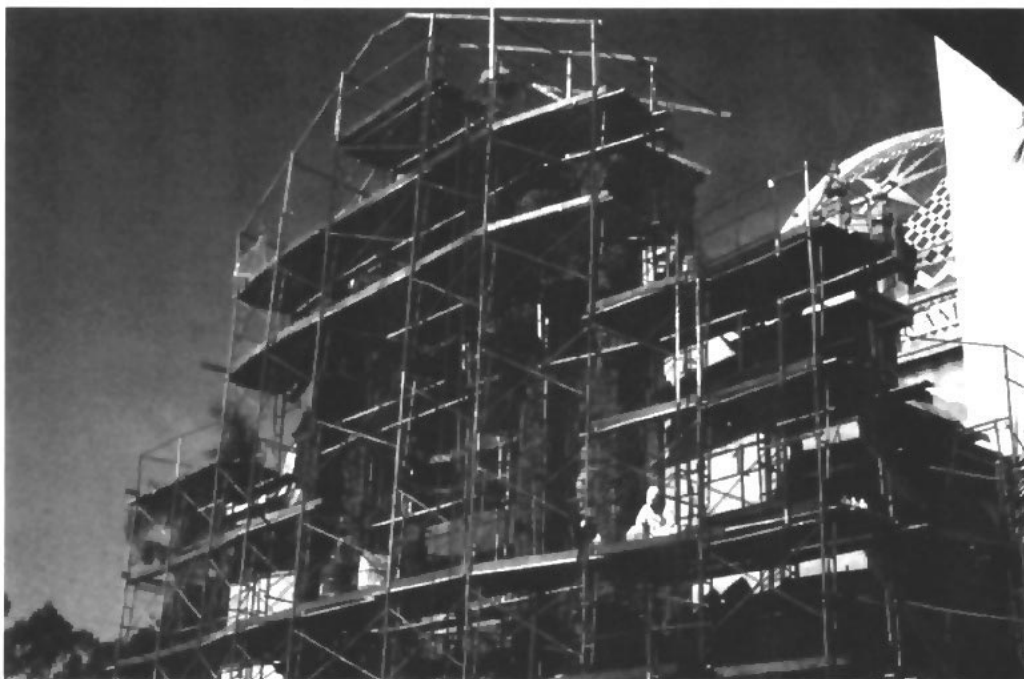
*Figure 19. Scaffold for the restoration of the California Building. 1975. (Courtesy of K. L. Gauri).*

Further analytical diagnosis showed that loss of detail in the ornamentation was due to dissolution of the calcitic cement and separation of unbonded sand grains. The white incrustation on the interior walls was analyzed by X-ray diffraction and found to be a complex mixture of calcium, sodium sulfates, and chlorides. Some of these components were present in the stone originally. They were joined by salts deposited from ocean spray or formed by the attack of pollutants on the calcareous cement. The cast stone ornamentation is attached to structural concrete reinforced with iron bars that rusted and expanded. This caused sections of both the stone and the concrete to rupture. To respond to this array of problems, a treatment had to be designed that would improve abrasion resistance and mechanical strength and decrease water absorption.

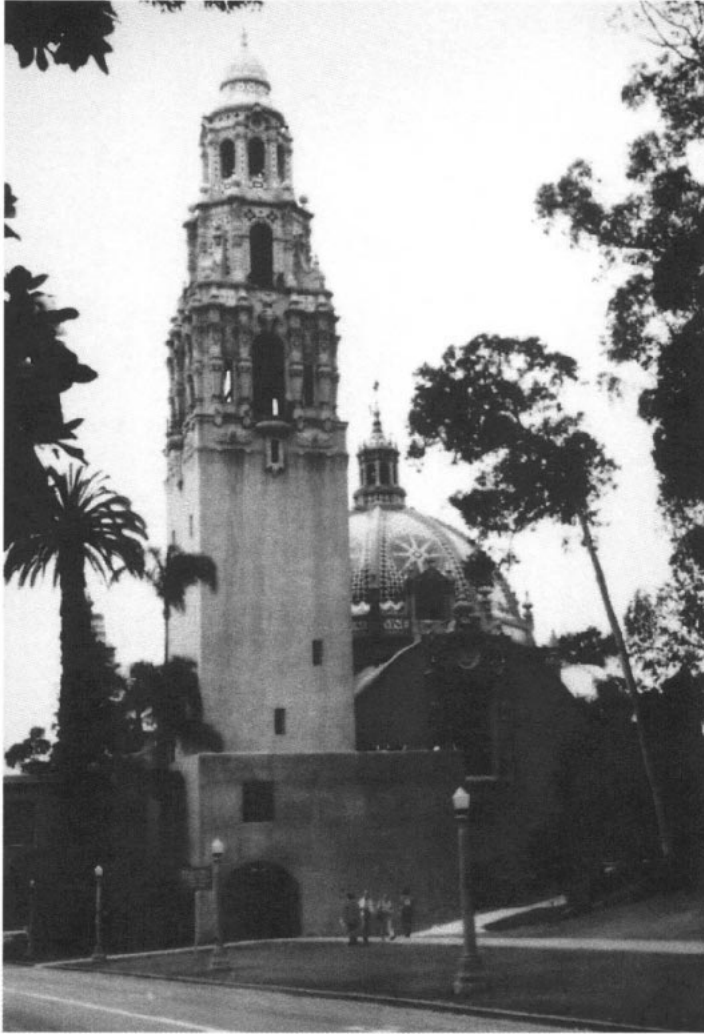
*Figure 20. The California Building soon after restoration was completed. 1982. (Courtesy of K. L. Gauri).*

solutions of epoxy resin in acetone. Discoloration of treated areas by polymer was avoided by removing resin left on the surface. Gauri (1978) mentions the use of abrasion, but Szabo (1982) describes washing the stone with acetone.

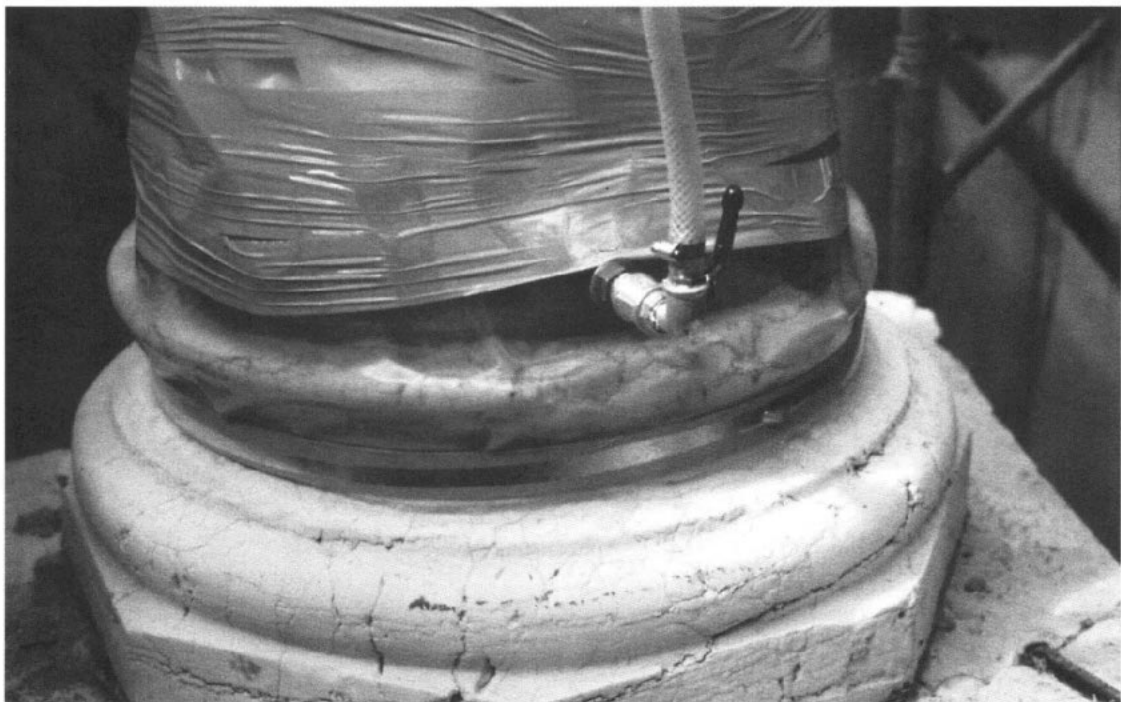
Figure 22. Containment around a granite column (Lazzarini 1991).

After a period of laboratory evaluation (Chapter 7, "Aliphatic Epoxy Resins"), the cycloaliphatic epoxy resin, EP 2101, produced by STAC of Milan, Italy was applied to the preservation of a number of important stone monuments in several Italian cities. The work was done by the Restoration Working Society of Cartura following procedures developed by Marinelli and Lazzarini (Chapter 9, p. 75). For stone impregnation, EP 2101, available commercially as a 25% solution in toluene and isopropanol, is mixed with aliphatic polyamines to provide a consolidating system

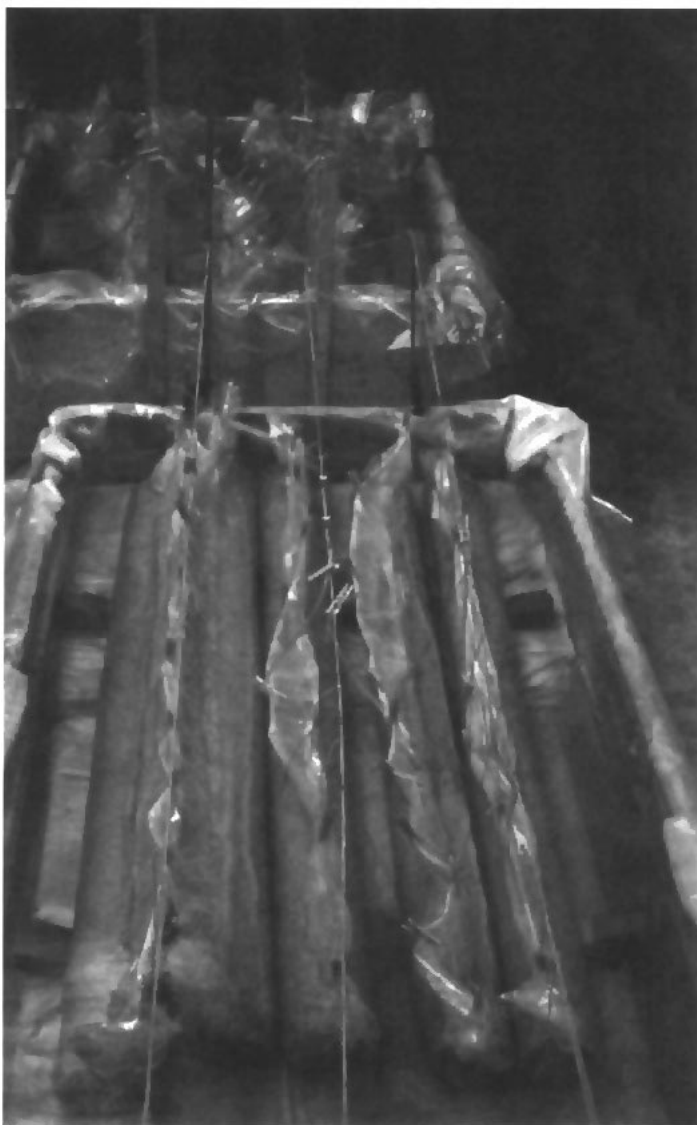
*Figure 25. Twin columns of the Basilica of Santa Andrea in plastic containment in wood boxes (Lazzarini 1991).*

A deteriorated base of a statue in the Church of Santa Maria Maggiore in Trent and the twin columns of the Basilica of Santa Andrea were restored in the laboratories of the Restoration Working Society. Each piece was wrapped in a waterproof sheet and then immersed in water to the top of the stone. The space between the artifact and the envelope was filled with resin. Impregnation was aided by the pressure of the head of water against the surfaces. When

the resin had achieved a gelatin-like consistency, the pieces were removed and the surplus consolidant was wiped from the surface to leave well-consolidated products. For restoration of the twin columns of the Basilica of Santa Andrea in Montera, the columns and bases, were disassembled. Figure 23 shows the parts wrapped in plastic, the bases in the background and the columns in foreground. The boxes are plastic lined to hold the water. Figure 24 shows the twin bases wrapped in plastic to contain the epoxy solution while Figure 25 illustrates the removal of the gel left by the excess resin solution.
